Villa Kennedy Housing Complex Reconnaissance Inspection

VILLA KENNEDY HOUSING COMPLEX STORMWATER AND WASTEWATER COLLECTION SYSTEMS

Reconnaissance Inspection: Municipality of San Juan Municipal Separate Storm

Inspection Date: July 16, 2014

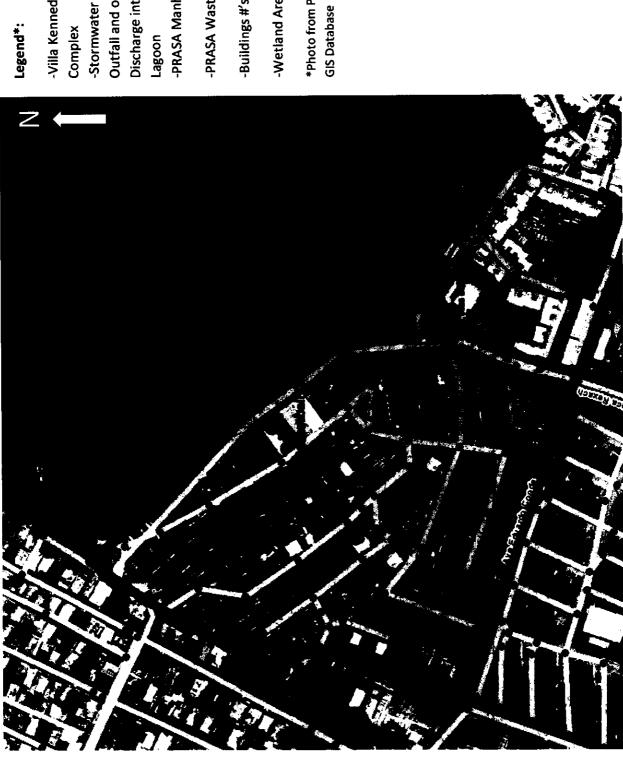
Figure 2: Villa Kennedy Housing Complex Findings Layout

- 13. Sewage was observed flowing from a pipe located in front of Building #4 and apartment #55 into the stormwater collection system.
- 14. A wastewater manhole located in the sidewalk and corner of Building #15 was observed with high levels of sewage. The manhole was found with high levels of wastewater and with green markings that allegedly were made by PRASA to identify an issue with the wastewater collection system between Building #15 and #19. The residents claimed that the area has been subject to wastewater overflows during the past years.

- 15. Aside of the wastewater flows related to PRASA's system reaching the stormwater collection system the most critical condition found was the fact that the majority of the buildings were documented with pipes conveying greywaters into the stormwater collection system.

- 17. The wastewater collection open channels that convey stormwater into the Los Corozos Lagoon were found clogged by vegetation, trash and other materials.

- 18. Several stormwater catch basins were observed full of solids. Others like the ones located to the west of Building #37 were found broken and posing a safety issue to the residents of the complex.

- 19. During the inspection we found the estuarine wetland area of the Los Corozos Lagoon located to the northwest part of the Villa Kennedy Housing Complex being filled by construction and demolition debris and other rubbish. The estuarine wetland vegetation was also impacted and removed in some areas. The Los Corozos Lagoon was also found with significant amounts of trash and other solids accumulated on its shore.

PRASA and MSJ shall include as part of their response to this inspection report the actions taken to comply with their respective NPDES permits. MSJ and PRASA must add these non-compliance items to its Action Registry, and work to correct them in an expeditious manner. If any items requires extensive repairs and/or capital investments, PRASA and MSJ must ensure they are added to the Action Registry according to the established priorities. MSJ shall identify and eliminate the illicit discharges (e.g. sewage, greywaters) into their stormwater collection system. MSJ and PRASA shall work together with the community on establishing an education campaign to ensure the correct use of the sewer systems in the area and to expedite the response to citizen complaints.
